Accessory Drive Tensioner

by Al Steadman, Litens

VW Europe TSB: **Accessory Drive Tensioner** **Ineffective, Broken**

Procedure No.: 250901/3
Approval Date: 20.06.2006

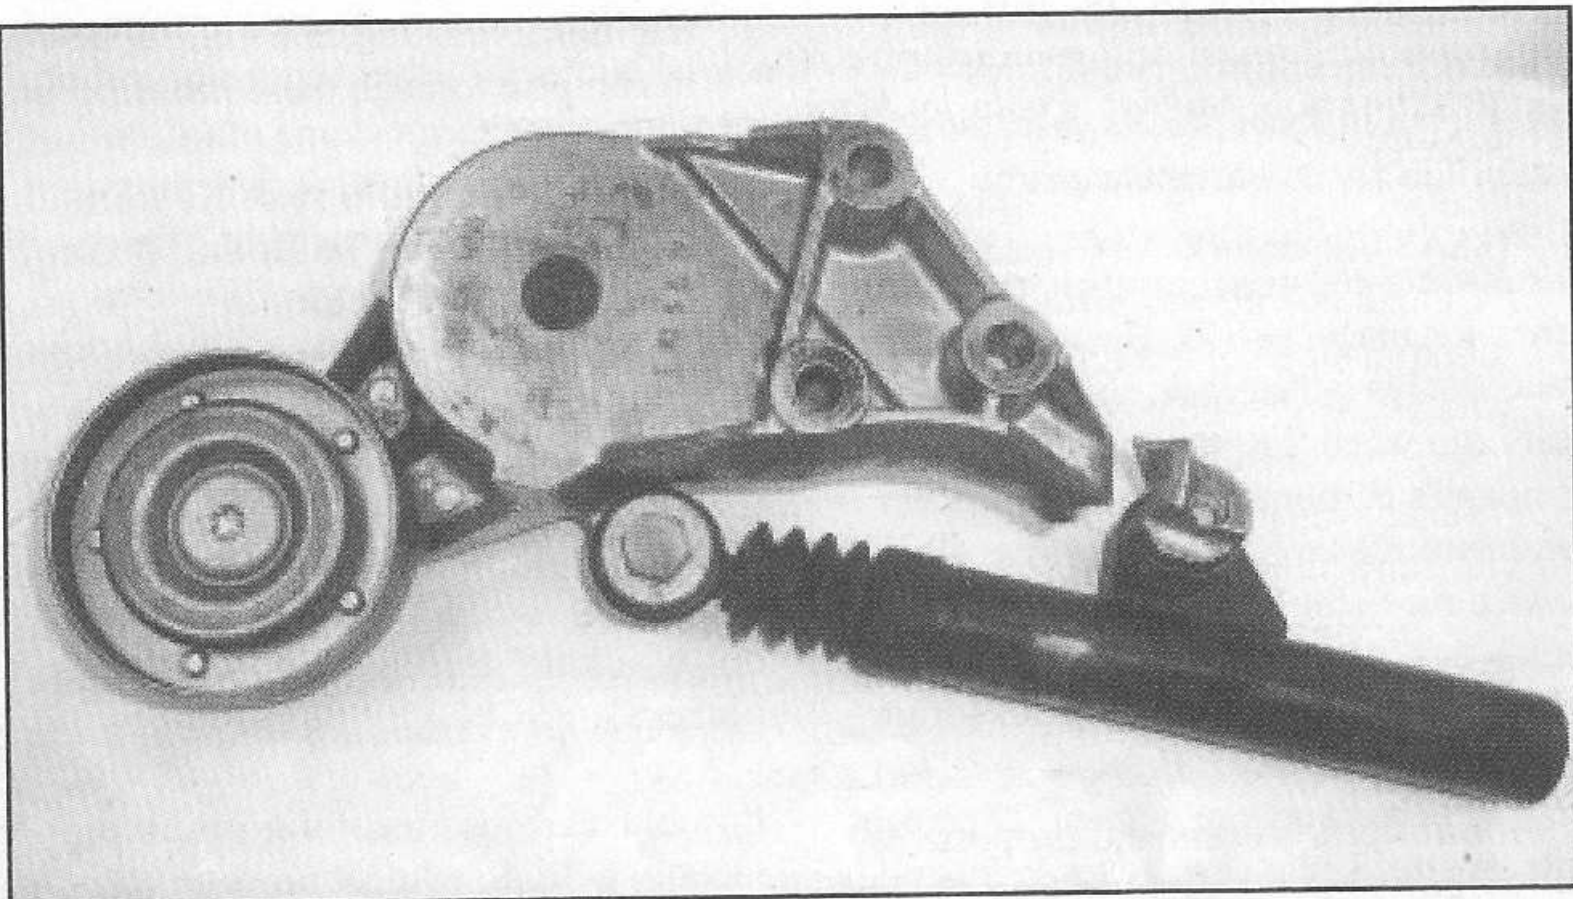
It appears that the worldwide electrical rebuilding industry still has not learned that cutting corners may have serious consequences and end up costing the owner more in the long run. VW Europe has just recently issued a technical service bulletin (see below) regarding the substitution of solid alternator pulleys for one-way clutch pulleys. The swapping in of the cheaper solid pulley in a belt drive system that has been designed with a one-way clutch pulley or Litens OAD may cause the tensioner to break apart.

The tensioner failing is directly related to the increased vibration levels within the belt drive system once the solid pulley is installed. Bottom line is, you should always check the Lester Kwikfinder (www.kwikfinder.net) or your local dealership to see if the alternator you are rebuilding requires a one-way clutch or a Litens OAD. Use only what the manufacturer has designed for the system.
