Foreign Service

A new drive belt component may cause some underhood head-scratching. Dan explains the operation and diagnosis of the isolator decoupler pulley, a crafty noise reducer and mileage increaser.

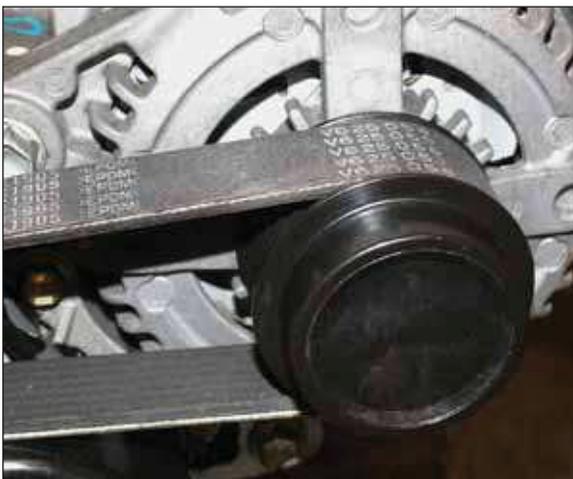
Have you seen something unusual on the newest Toyotas? For instance, does the alternator pulley look different from earlier designs? If you noticed a change here (see photo below), you're very observant *and* you've caught an important trend—increasing usage of the Overrunning Alternator Decoupler Pulley OAD.

Photo: Dan Marinucci

However, as the OADs name suggests, it does more than just freewheel or “decouple” when the engine decels. Besides having a one-way clutch, the Litens OAD also has a special spring inside it, in series between the drive pulley and the rotor. To grossly simplify, this thing looks like a horizontal coil spring connecting the drive pulley to the rotor. So when the engine is driving the alternator, the power flows from the drive belt to the pulley, then through this special spring to the rotor. Not only does the spring transmit power to the rotor, it also isolates or cushions the rotor from the alternator pulley and the drive belt system.

There are only a few details you need to remember about diagnosing problems with an OAP or OAD. Both components have an overrunning or one-way clutch. Experience shows that the single most common problem on higher mileage units is bearing noise. That is, the drive belt system and all accessories work fine. But a worn bearing inside that one-way clutch causes a brief buzzing sound during engine shut-down. The customer also may hear this momentary buzzing when the transmission makes the 1-2 shift.

Occasionally, the one-way clutch breaks, allowing the alternator pulley to freewheel in both directions. Then the vehicle comes in with a dead battery and a no-charge condition. Suppose you shut off the ignition switch and try to turn the alternator pulley with a strap wrench or turning/holding tool of some kind. If the pulley freewheels in both directions, the one-way clutch has failed. What's more, you may be able to watch the rotor and/or an internal cooling fan through the air openings on some alternators. If so, carefully shine a light in there while the engine is running. If the alternator pulley is turning but the rotor isn't, the one-way clutch has failed.
